Master Facility Plan

Year 2024

Re: Immanuel Christian Elementary School Condition Assessment

Immanuel Christian School Condition Assessment
Immanuel Christian Elementary School

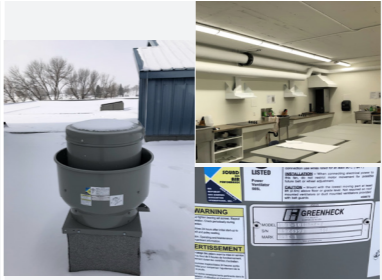
Exhaust fan on roof is by Greenheck, Model CLRE-101HO-4-X, and is in fair condition. The Exhaust hoods in Outdoor Education room are in fair condition. Upgrades are not expected for the next 10-15 years (\$3,000). MPE recommends all the older exhaust fans for washrooms to be replaced as the washrooms are upgraded in the next 5-10 years (\$5,000.00).	\$ 8,000.00
Exhaust systems capacity and condition.	P3
